## Induktiver Ringsensor

**203405**  
**IRD 6 PSOK-IBS**  
**Induktiver Ringsensor**

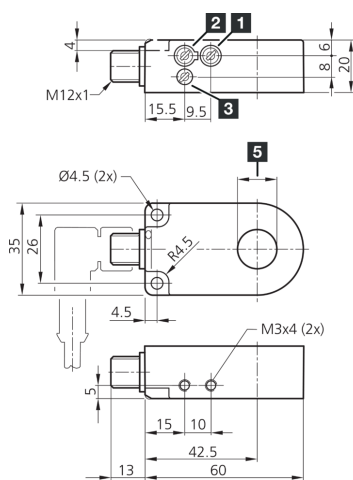
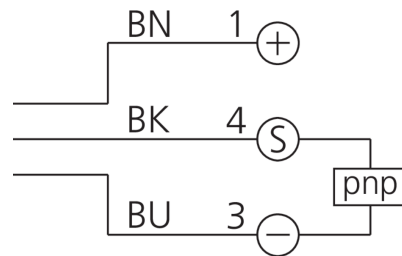
| Technische Daten (typ.) | | +20°C, 24 V DC |
| Anschluss | | Stecker, M12, 4-polig, A-kodiert |
